Restoration Method Statement – V2

for the Dome of the Parish Church of Saint Catherine in Żurrieq.

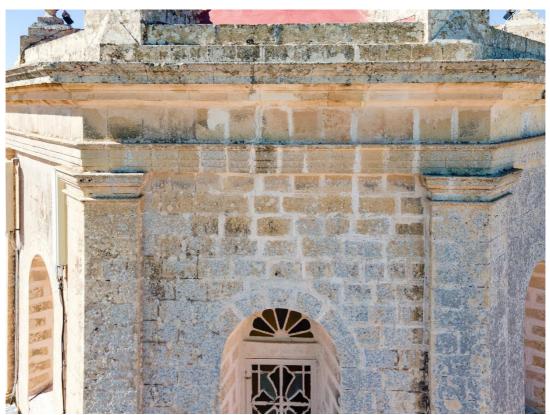
Biological growth, cement pointing and cement rendering to deteriorated elements.

5.2 Removal of Cement Renders

The removal of such renders shall be done carefully by hand tools using manual methods so as to contain damages to the underlying masonry work. Electrical tools as well as tipped metallic instruments with sharp edges or corners, power tools (such as rotating disk cleaners) and sand blasting (dry or wet) shall not be permitted.

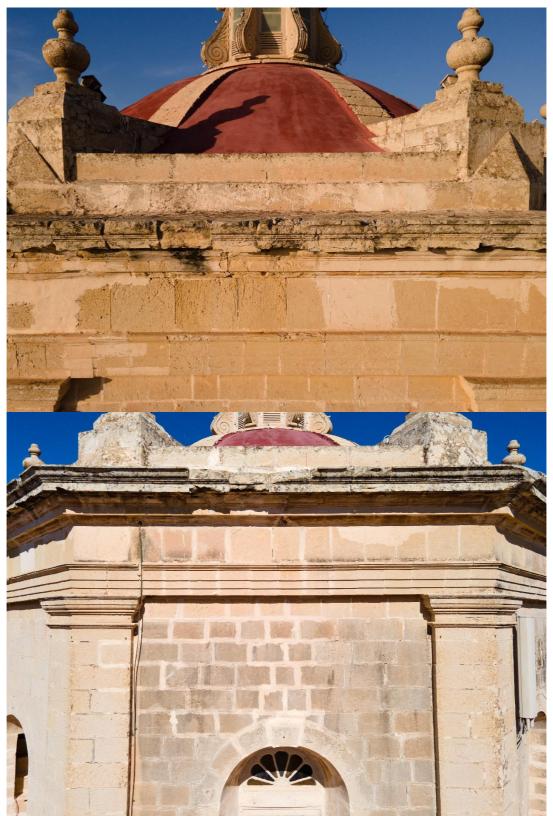
Missing parts in the cornice, and cement pointing and rendering of joints/ gaps.

It is foreseen that in most cases **Piecing-in** will be carried out in most areas, in which a piece of stone is added to fill in a missing area or replace a part of a deteriorated stone by the insertion of an appropriately cut stone piece, attached using structural adhesives (e.g. epoxy or polyester adhesives).
